SIGAR 16-26 Inspection Report

Afghan Air Force University: Contract
Requirements Were Generally Met, but
Instances of Non-Compliance, Poor
Workmanship, and Inadequate Maintenance
Need to Be Addressed

**MARCH
2016**

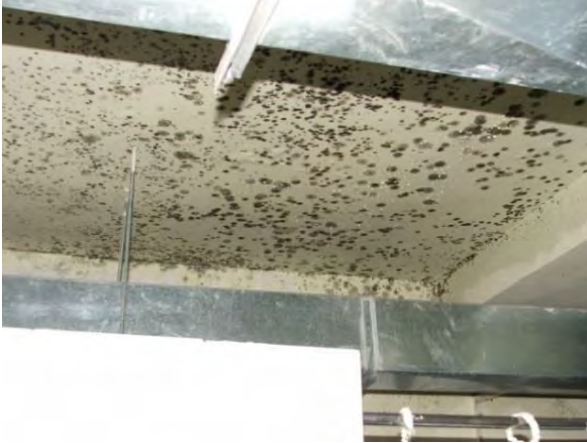
Photo 1 - Mold Growth in Bathroom Building 7a

We also found that 2 of the 10 buildings that USACE transferred to Afghan authorities in April 2015 were not being used. Agency officials explained that no furniture had been moved into barracks Nos. 1 and 4 because Afghan authorities discovered multiple problems, including plumbing leaks in the bathrooms, broken sinks and fixtures, and non-functioning ceiling fans. In addition, during our inspection, we found other problems with various buildings that can mostly be attributable to inadequate maintenance by the Afghan government, including mold growth, filthy bathroom conditions, broken door locks, and broken or missing plumbing fixtures. Photos 1 and 2 show examples of mold and poorly maintained bathrooms, respectively.

We conducted a review and will ensure that items still under warranty do not appear on the Statement of Requirements list. To note, the Statement of Requirements includes non-warranty mold remediation which is due to leaking supply and drain pipes in the barracks buildings and a lack of maintenance in these buildings.

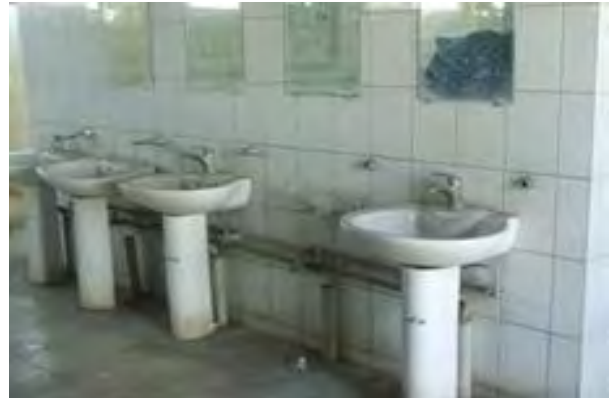
Photo 2 - Poorly Maintained Facilities in Bathroom Building 7

At the time of our March 2015 site visit, we found that the four bathroom buildings transferred to Afghan authorities in April 2014 were not being used. However, according to USACE officials, these four buildings are now being used by Afghan students and staff, despite the fact that a number of sinks and faucets are broken, some light bulbs are burned out, and the water heaters are not functioning.
